Arboricultural Report

Tree Survey,
Arboricultural Impact Assessment &
Arboricultural Method Statement

Devoy Barracks

191203-PD-11-D

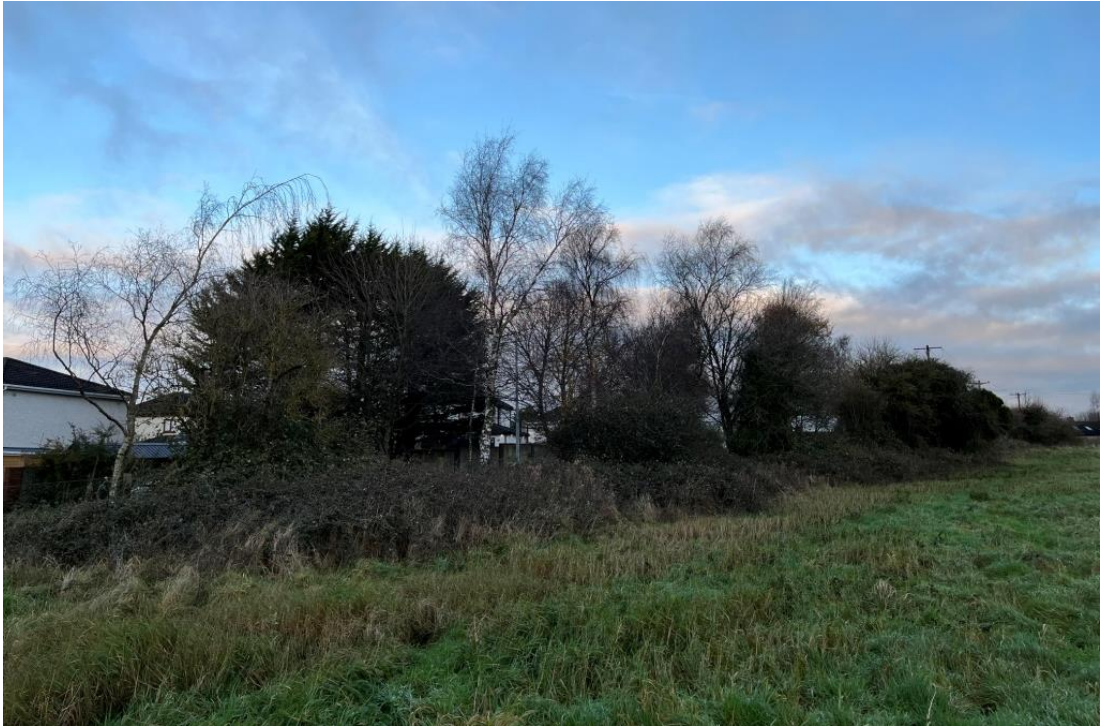
Photo 1: View of the western boundary tree cover which comprises mainly of elder and hawthorn within the site and silver birch trees within the neighbouring Arconagh residential estate.

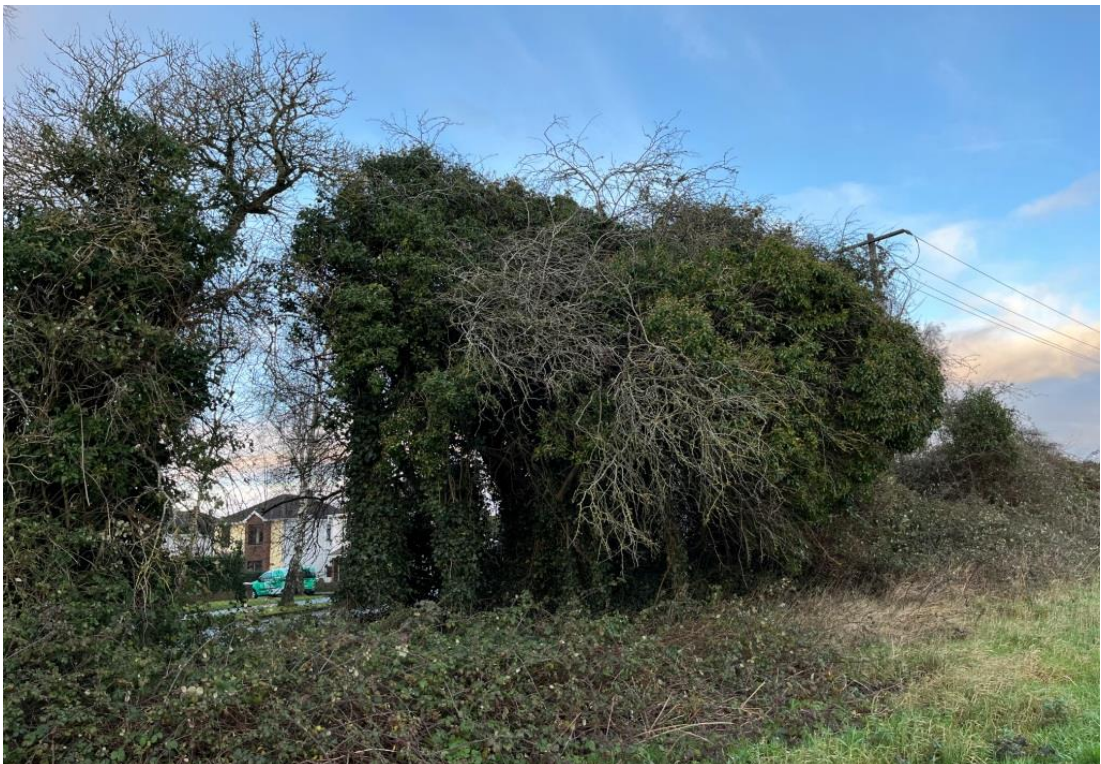
Photo 2: Close up view of the of the hawthorn and elder (T481 to T485) along the western boundary.

Tree T482	1 Sambucus nigra (Elder)	5.0	25	1	2.5		0.0		2.0		4.5		0.0		Early Mature	Structural condition Poor. Physiological condition Fair. Competition - Adjacent trees. Deadwood - Minor. Leaning trunk - Minor. Suppressed crown - Major. Unbalanced crown - Major. Unable to inspect tree closely due to ivy cover.	15/12/2021	28.3	3.0	10-20	C2
Tree T483	1 Crataegus monogyna (Common Hawthorn/Quick/May)	6.0	48 COM	4	3.5		5.5		3.5		3.0		1.0		Mature	Structural condition Fair. Physiological condition Fair. Access to inspect base - Restricted / obscured. Competition - Adjacent trees. Ivy or climbing plant. Suppressed crown - Major. Unable to inspect tree closely due to ivy cover.	15/12/2021	104.2	5.8	10-20	C2
Tree T484	1 Crataegus monogyna (Common Hawthorn/Quick/May)	7.0	25	1	3.5		4.0		1.0		3.0		3.0		Early Mature	Structural condition Fair. Physiological condition Fair. Access to inspect base - Restricted / obscured. Competition - Adjacent trees. Ivy or climbing plant. Suppressed crown - Major. Unbalanced crown - Minor. Unable to inspect tree closely due to ivy cover.	15/12/2021	28.3	3.0	20-40	C2

Tree T485	1 Crataegus monogyna (Common Hawthorn/Quick/May)	7.0	35	1	4.0		3.5		2.0		3.5		1.0		Mature	Structural condition Fair. Physiological condition Fair. Access to inspect base - Restricted / obscured. Competition - Adjacent trees. Ivy or climbing plant. Unable to inspect tree closely due to ivy cover.	15/12/2021	55.4	4.2	20-40	C2

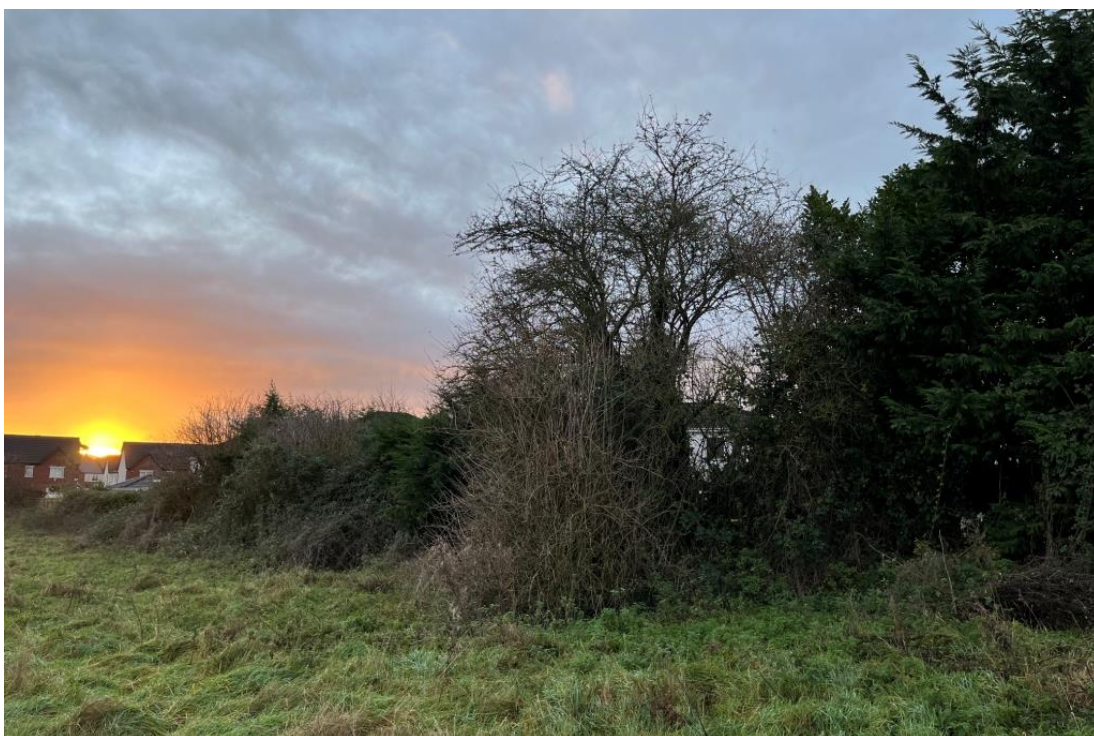
Photo 3: View of the southern boundary which includes neighbouring trees and hedgerows such as hawthorn and Leyland cypress that overhang into the site (H426 to H432).

Hedge H432	3 Sambucus nigra (Elder) 10 x Cupressocyparis leylandii (Leyland Cypress)	5.0	18 AVE	1									0.0		Early Mature	Structural condition Fair. Physiological condition Fair. Arboricultural work - Historic. Hedgerow - Maintained. Natural regeneration. Height and stem diameter are average for group. Hedgerow located in neighbouring property but overhanging into site beyond by approx. 2m beyond fence. Group of trees have been topped. Quantities are estimated only.	15/12/2021	14.7	2.2	10-20	C2
Tree T433	1 Betula pendula 'Youngii' (Young's Weeping Birch)	5.5	20	1	4.0		4.0		3.0		2.0		1.0		Early Mature	Structural condition Good. Physiological condition Good. No significant faults observed. Tree is not tagged as located in neighbouring property.	15/12/2021	18.1	2.4	20-40	C1/C2
Tree T434	1 Sorbus sp. (Sorbus sp.)	5.5	16	1	2.0		2.0		1.5		2.0		1.0		Early Mature	Structural condition Fair. Physiological condition Good. Bark wound - Minor. Fork - Weak with included bark. Tree is not tagged as located in neighbouring property.	15/12/2021	11.6	1.9	20-40	C2

ID	No. / Species	BS5837 Category	Purpose of works Recommended works	Status
H425	25 <i>Laurocerasus officinalis</i> Cherry Laurel	C2	To facilitate development Reduce lateral limb / limbs. Reduce overhanging lateral growth back to boundary to facilitate the installation of boundary treatment.	Proposed
H426	3 <i>Crataegus monogyna</i> Common Hawthorn/Quick/May 3 <i>Sambucus nigra</i> Elder 10 <i>x Cupressocyparis leylandii</i> Leyland Cypress	C2	To facilitate development Reduce lateral limb / limbs. Reduce overhanging growth and scrub back to the site boundary.	Proposed
T427	1 <i>Crataegus monogyna</i> Common Hawthorn/Quick/May	C2	To facilitate development Reduce lateral limb / limbs. Reduce lower overhanging lateral growth back to boundary to facilitate the installation of boundary treatment.	Proposed
T428	1 <i>Crataegus monogyna</i> Common Hawthorn/Quick/May	C2	To facilitate development Reduce lateral limb / limbs. Reduce lower overhanging lateral growth back to boundary to facilitate the installation of boundary treatment.	Proposed

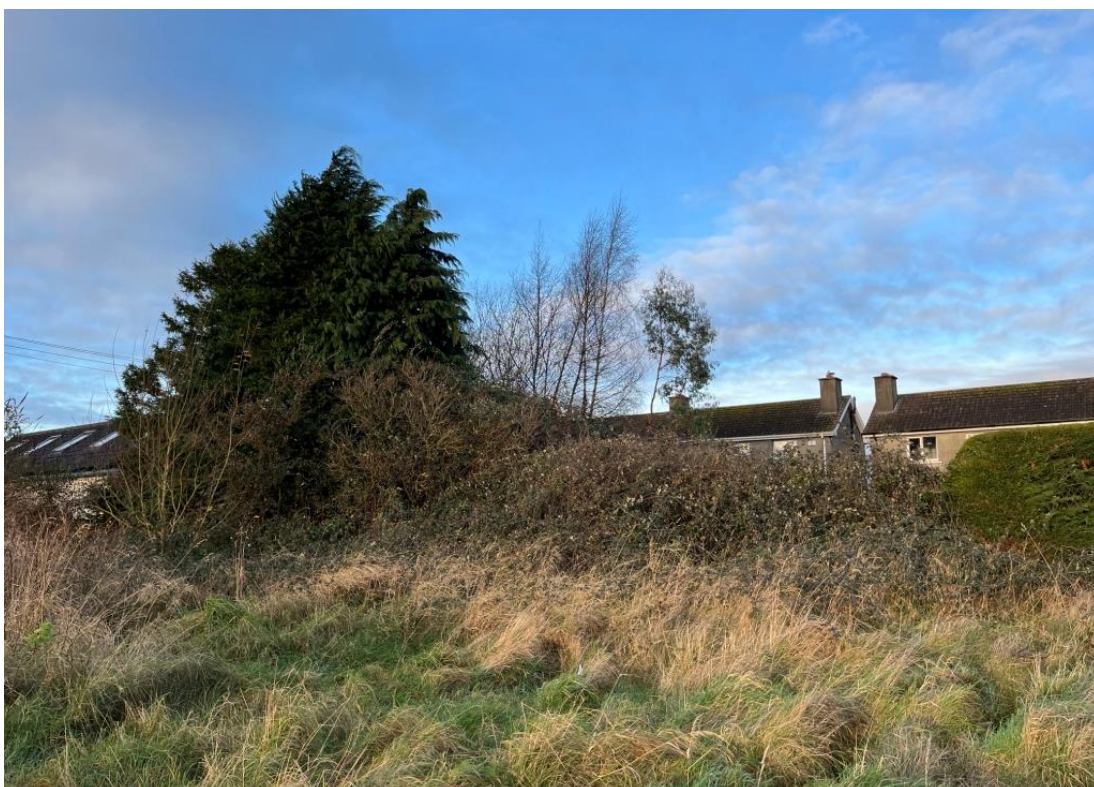
Photo 4: View of the northern boundary neighbouring trees and hedgerows (G470 and H471).

Tree ID	No. Species	Height (m)	Stem diameter (cm)	No. of Stems	CROWN SPREAD (m)								Crown clearance (m)	L.B. (m)	Life stage	Condition Notes	Survey date	RPA (m ²)	RPR (m)	Life expectancy (yrs)	BS Category
					N	NE	E	SE	S	SW	W	NW									
Group G470	3 Chamaecyparis lawsoniana (Lawson Cypress)	7.5	20 AVE	1									0.0		Early Mature	Structural condition Fair. Physiological condition Good. Access to inspect base - Restricted / obscured. Competition - Adjacent trees. Height and stem diameter are average for group. Trees located in neighbouring property, laterals overhanging into site by approx. 1.5-2m.	15/12/2021	18.1	2.4	20-40	C2
	2 Picea abies (Norway Spruce)																				
Hedge H471	6 x Cupressocyparis leylandii (Leyland Cypress)	2.0	15 AVE	1									0.0		Early Mature	Structural condition Fair. Physiological condition Fair. Hedgerow - Maintained. Height and stem diameter are average for group. Hedgerow located in neighbouring property. Quantities are estimated only.	15/12/2021	10.2	1.8	10-20	C2

ID	No. / Species	BS5837 Category	Purpose of works Recommended works	Status
G469	2 <i>Crataegus monogyna</i> Common Hawthorn/Quick/May 7 <i>Sambucus nigra</i> Elder	C2	To facilitate development Fell - Ground level.	Proposed
G470	3 <i>Chamaecyparis lawsoniana</i> Lawson Cypress 2 <i>Picea abies</i> Norway Spruce	C2	To facilitate development Reduce lateral limb / limbs. Reduce lower overhanging lateral growth back to boundary to facilitate the installation of boundary treatment.	Proposed
H471	6 <i>x Cupressocyparis leylandii</i> Leyland Cypress	C2	To facilitate development Reduce lateral limb / limbs. Reduce overhanging lateral growth back to boundary to facilitate the installation of boundary treatment.	Proposed
G472	3 <i>Sambucus nigra</i> Elder	C1	To facilitate development Fell - Ground level.	Proposed
T479	1 <i>Salix caprea</i> Goat Willow/Great Sallow	C2	To facilitate development Fell - Ground level.	Proposed
