Archaeological Assessment at Devoy Barracks, Naas, Co. Kildare Licence number Ext 21E0471 January 2022

Client: Land Development Agency, Second Floor, Ashford House, 18-23 Tara Street, Dublin 2 D02VX67

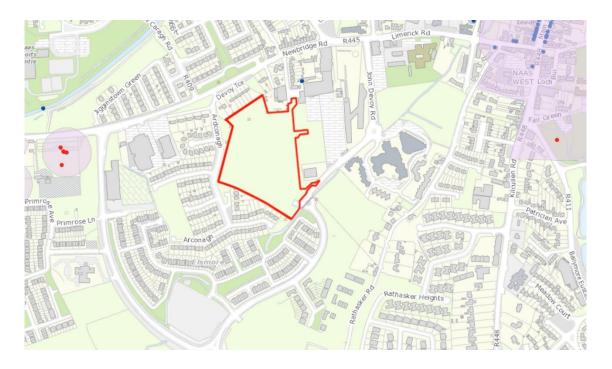
Figure 2: Study area with archaeological monuments in the environs marked

Although the site does not include any recorded monuments a number of recorded monuments are located in the environs of the study area these are listed below (all information taken from archaeology.ie).

RMP	Townland	Site Type	Distance to Site
KD019-030001	Naas	Medieval Town	800m east
RMP KE 019 033	Jigginstown	17 <sup>th</sup> Century	380m west
		House	
KE 019 030	South Moat	Moated Site	700m east
KD019-030051	Naas East	Excavation	750m east

The study area consists of a landbank in Naas West, Naas, Co. Kildare. The study area does not include any archaeological remains, Jigginstown House is located 400m to the west and the medieval Town of Naas is 800m to the east (Table 1 and Figure 2). These will be unaffected by the proposed works.

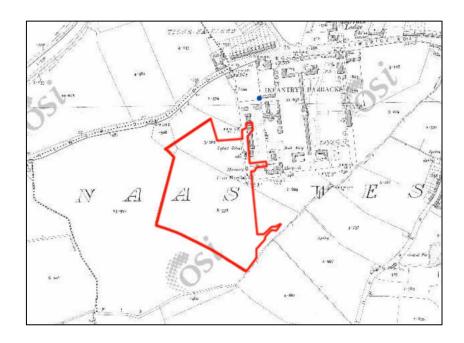
Figure 4: 25" map for the study area

The proposed development is located in the townland of Naas West in the in the north of Co. Kildare. The area is currently in use as rough pasture, clearance works were undertaken at the site to facilitate the archaeological testing. The site is located adjacent to Devoy Barracks a 19th century military barracks. A section to the east of the site contained a number of features associated with the barracks, including the mortuary, infant school and fever hospital.

These are visible on the 25" map for the site (Figure 4). These are not visible at ground level. The site is bounded by the local road network at the south, by the barracks at the east and by modern housing at the west and north.

The site also includes the western extent of Devoy Barracks (Figure 4). The area does not include any above ground remains of the barracks. Cartographic evidence for the site shows the western extent of a mortuary, infant school and fever hospital were located in this area. These were not marked on the first edition OS map and date to the late 19th century. These remains will be located within a linear park at the east of the site where deep excavation will not occur. This will allow for any sub surface features associated with the barracks to be preserved in-situ.

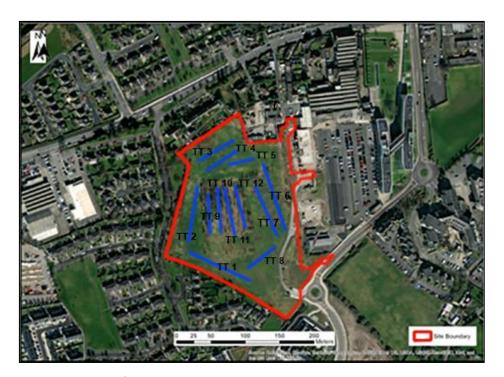
Figure 5: Test trenches undertaken

A series of test trenches were excavated across the study area in July 2021, this did not include the centre of the site which were excavated in January 2022 (Figure 5). No archaeological finds or features were identified during the archaeological testing.

When the brush and trees were removed from centre of the site it was shown that this section of the site had been truncated by 0.6m at the south and by 0.4m at the north.

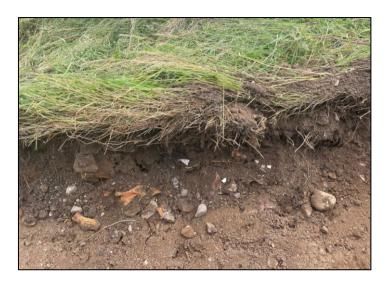
Plate 1: Modern rubble visible is section of Test Trench 1

This was located at the west of the proposed development and was orientated northwest to southeast. The trench was 1.5m in width and was excavated for a length of 90m. The trench was excavated by machine using a grading bucket. The topsoil was 0.3m in depth. The subsoil was exposed across the trench. The trench contained areas of modern rubble at the south a number of drainage channels that included fragments of 20<sup>th</sup> pottery. No archaeological finds or features were noted.

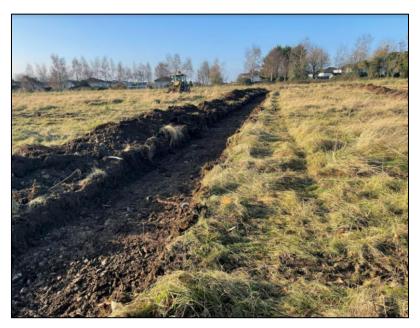
Plate 6: Looking northwest as test trenches were being excavated, with test trench 11 visible

This was located at the centre of the proposed development and was orientated north to south. The trench was 1.5m in width and was excavated for a length of 70m. The trench was excavated by machine using a grading bucket. 0.3m of soil was removed to expose subsoil across the trench. No archaeological finds or features were noted.
