Arboricultural Report

Tree Survey,
Arboricultural Impact Assessment &
Arboricultural Method Statement

Devoy Barracks

191203-PD-11-D

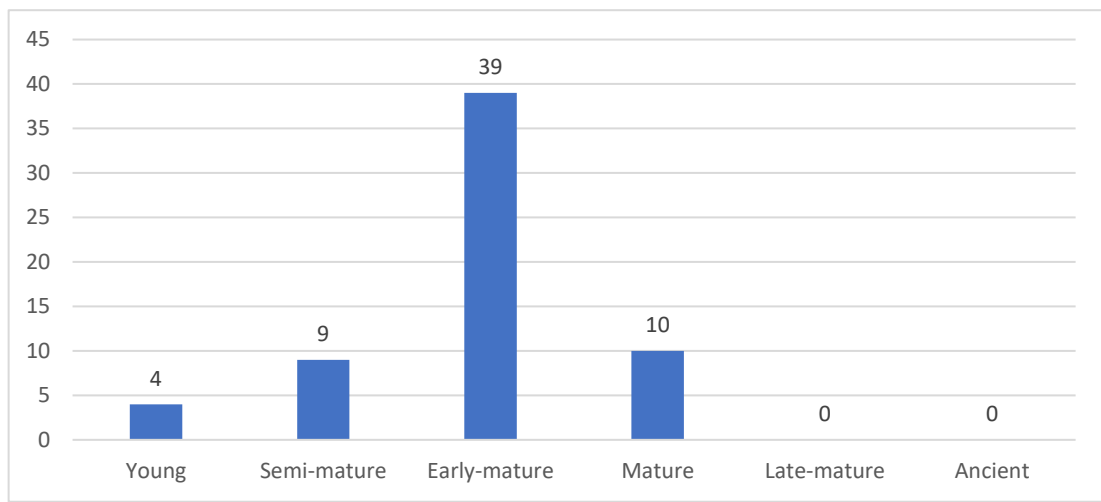
Figure 1: Life stage analysis of the 62 survey entries recorded. The majority of trees assessed are of an early-mature age.

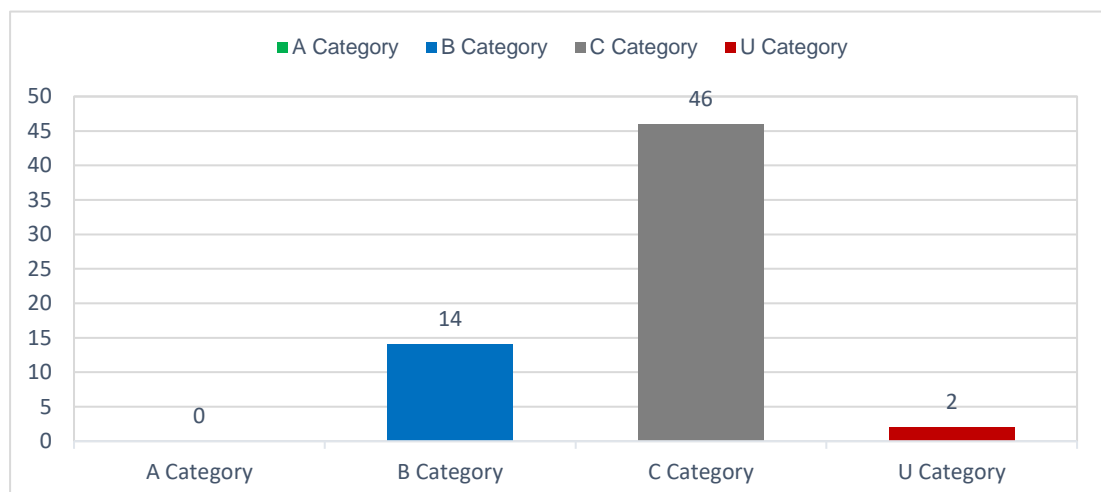
Figure 2: Breakdown of BS5837:2012 categories of the 62 survey entries recorded on and adjacent to the site. The majority of the trees are of low quality and value (C Category).

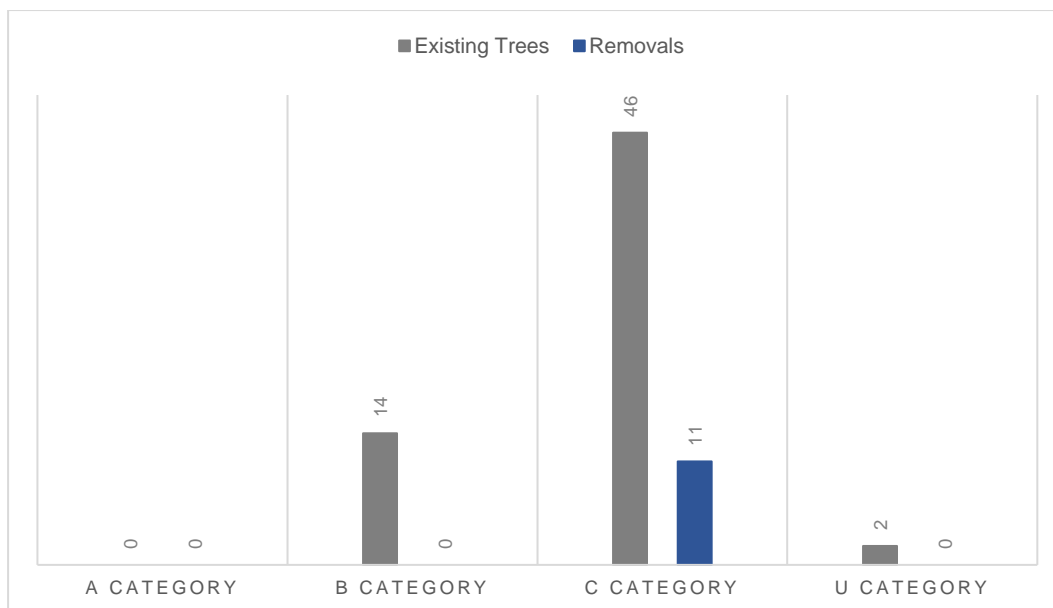
- 6.1 **Loss of trees** – The proposed development will require the removal of eight trees and three groups of trees, all of low quality and value (C Category). Details of the proposed removals are specified within the Tree Work Schedule at Appendix A and shown on the Tree Removals Plan at Appendix B.

Figure 3: Proposed removals in comparisons to the total number of survey entries recorded and their category in accordance with BS5837:2012.
